**GENUINE
PARTS**

For Ford, Lincoln and Mercury Wholesalers and the Collision Repair Industry

2010 Ford TAURUS – Functionality, Damageability and Reparability

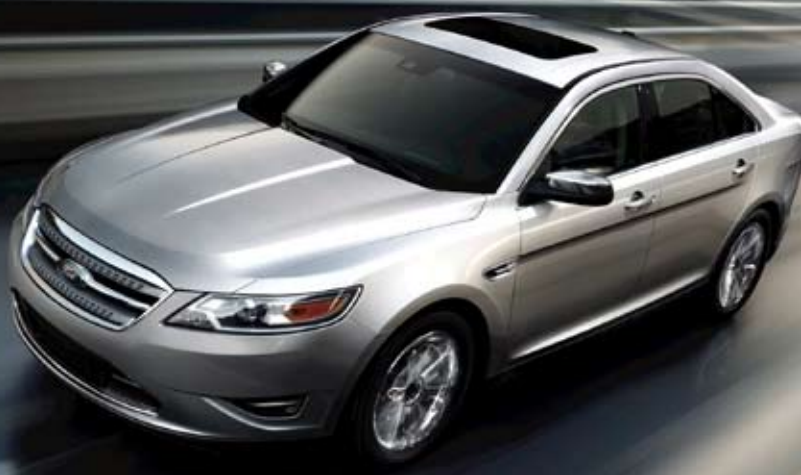
The all-new, upscale 2010 Ford Taurus confidently leads a growing wave of new-car introductions from Ford Motor Company. Having arrived at dealers during the later part of the summer, this distinctive new vehicle combines class-leading technologies with confident, engaging driving dynamics. At the same time, Taurus SHO returns as the sporty version of Ford's new flagship.

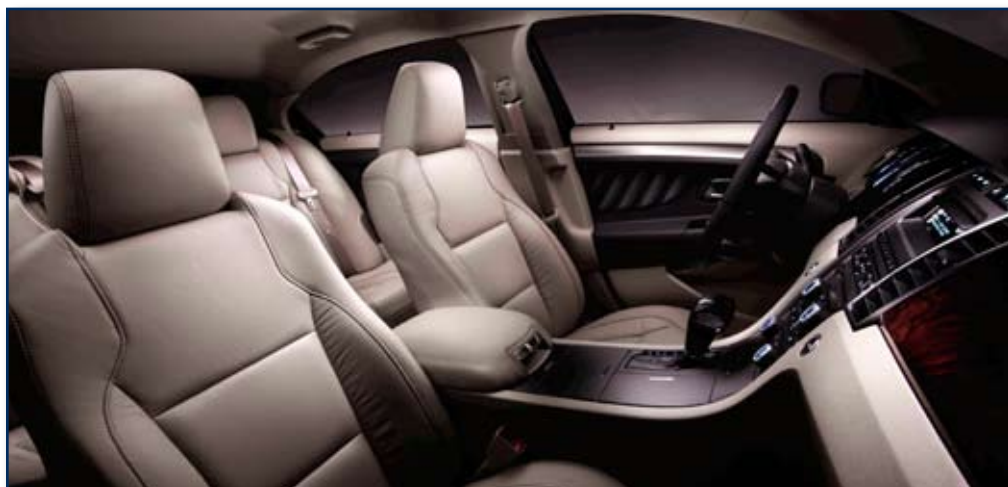
- Duratech 3.5L V6
 - 263 hp / 249 lb-ft torque
 - FWD & AWD
- 3.5L EcoBoost V6 (SHO)
 - Twin-turbo direct injection
 - 365 hp / 350 lb-ft torque (with premium fuel)
 - AWD
- 6-Speed Automatic (SE)
- 6-Speed SelectShift-Automatic™ with paddle shifters (SEL, Limited & SHO)

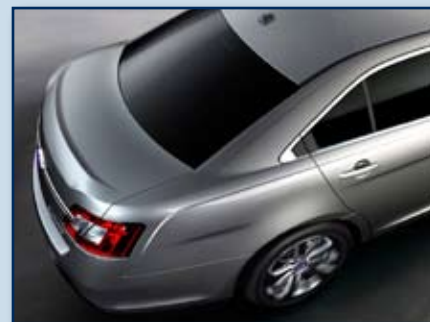
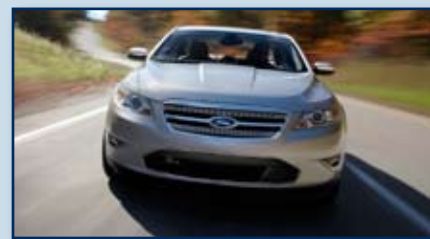
Damageability / Reparability

- The Taurus shares the same platform with the Lincoln MKS, Ford Flex and Lincoln MKT, so it will have the same under body reparability features, including three rail-sectioning options.
- Front rail-sectioning procedures are available and documented in sections 501-35 of the workshop manual.
- Front door outer panels will be available for service, with the repair procedure also appearing in sections 501-35 of the workshop manual.
- Blind Spot Information System (BLIS®) modules are located behind the rear fascia, mounted to the lower quarter panel. Please see the workshop manual for details.
- Adaptive Cruise Control module is located behind the front fascia. Please see the workshop manual for further details.
- The outer body panels are steel.
