Attachment "F" – Rubber Gasket

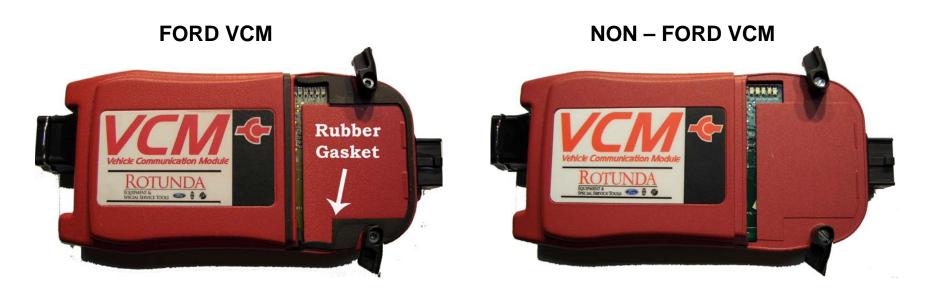
The Rotunda (OE) VCM has a rubber gasket under the plastic cover. Some of the non-genuine units do not have this gasket.
