PARKING AID SYSTEM SERVICE HELP SHEET

(00 - 02, 04) Expedition, (01-02) Navigator, & (99 - 04) F-Series, Explorer, Mountaineer, Aviator, Excursion, Escape, Windstar, Freestar, and Monterey

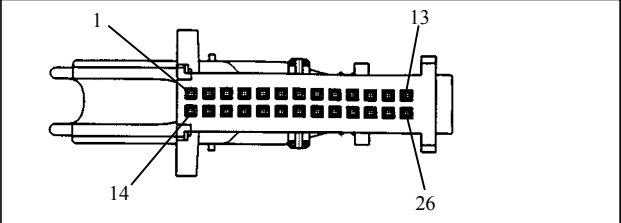
Wiring Harness Connector View for 26-way PAM

(Applies to Expedition, 01-02 Navigator, Windstar, F-Series Super Duty, Explorer, Mountaineer, Aviator, Excursion, 03 - 04 Escape, and Monterey)

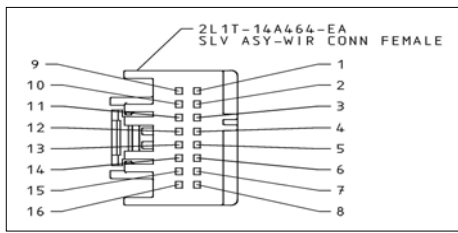
Wiring Harness Connector View for 16-way PAM

(Applies to F-150, 05+ Escape, and Freestar)
